4-7. Self Test Acquisition Test Procedure

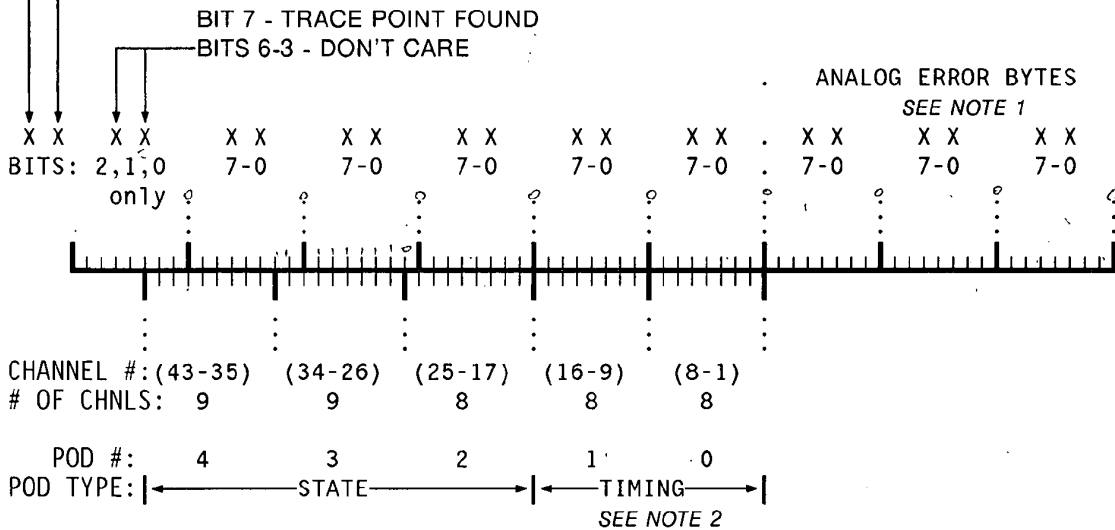
KEY 1 = Error (except Don't Cares)
0 = No Error

- Bit 0 - Incorrect acquisition data acquired.
- Bit 1 - "Measurement Complete" true when it should be false.
- Bit 2 - "Measurement Complete" IRQ true when it should be false.
- Bit 3 - Words remaining. State Master board counter incorrect.
- Bit 4 - "Measurement complete" on State Master board false when it should be true.
- Bit 5 - "Measurement complete" false when it should be true, no "interrupt" received.
- Bit 6,7 - Don't Care Bits

NOTE 1: Analog errors are only relevant in the 1631A/D. For 1630A/D this section of the error code will show all bits passing. For analog errors see paragraph 4-8.

NOTE 2: In the case of timing errors, channels 8-1 actually represent the Timing Master and channels 16-9 the Timing Slave. The example above represents a 1630/31D. If the instrument is a 1630/31A, the test will show channels 16-9 as passing and channels 8-1 will represent POD 1.

NOTE 3: Each pair of analog error bytes has 8 bits (4 bits per byte). Since the timing pods (pods 0 and 1) have 8 channels, the 8-bit pairs of error bytes interpret directly to the timing pods' 8 channels. However, the state pods (pods 2, 3, 4) have 9 channels, and the byte to channel interpretation is offset by one bit per pod. As in the diagram above, the one bit offset must be taken into account when interpreting acquisition errors.

The error message, a series of HEX digits must be converted to a binary equivalent before it can be fully interpreted. The following general example of a 1631D failure shows how this is done.

- a. This example shows that incorrect Acquisition data was acquired.
- b. Trace point was not found.
- c. All channels passed except pod 0 (Timing Master) Channels 1 and 0.
- d. All analog acquisition passed.
