8. Chapter 8. Troubleshooting

8.1 Procedure of Checking the Symptoms

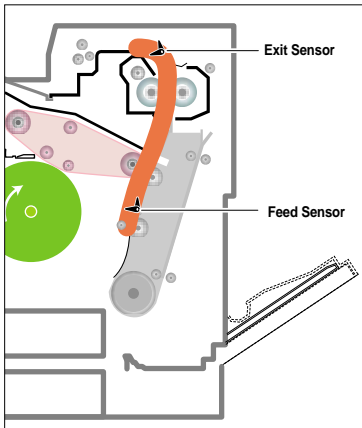
8.3.3 JAM1(JAM inside pinter)

Symptoms Paper is jammed in front of the Fuser or under the T2 Roller.

Check and Cause	Solution
<ol style="list-style-type: none"> 1. If the paper is jammed in front of or inside the Fuser 2. If the paper is caught in the Exit Roller and the Fuser check the Feed Sensor actuator opens and closes freely. 	<ol style="list-style-type: none"> 1. Replace the SMPS. 2. - Re-assembly the Feed Actuator and Spring, or clean the Hinge with a lint free cloth. - Replace the Main PBA.

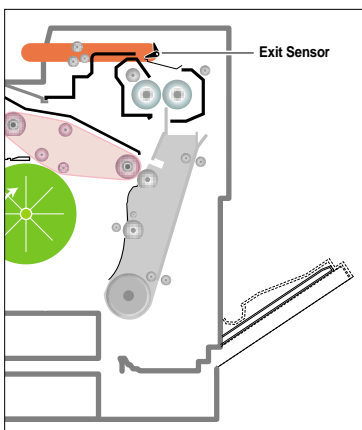
8.3.4 JAM 2 (Jam in Exit Area)

1. Paper is jammed inside the Fuser.
2. Paper is caught in the Exit Sensor Actuator.
3. Paper is caught in the Exit Roller and Fuser, after passing through the Feed Sensor actuator

Check and Cause	Solution
<ol style="list-style-type: none"> 1. The Exit Sensor is defective if Jam 2 occurs after the paper is completely fed out of the printer. This can happen if the actuator sticks open or is slow to close. 2. Paper is rolled into the Fuser. <ul style="list-style-type: none"> • “Accordion” folding occurs repeatedly. • Fuser temperature is too high due to failure or other abnormal conditions. • If the Heat Roller or Pressure Roller is contaminated hard because of Toner. 3. If there are “Accordion” paper folds inside the Fuser. 4. If the Exit Sensor is defective. a Jam In Exit Area will occur and printing will stop. 	<ol style="list-style-type: none"> 1. Check if the Exit Sensor Actuator is broken or damaged. <ul style="list-style-type: none"> • Check if the Exit Sensor Actuator is deformed (Check that the sensor arms are not deformed). • Check for Burrs or rough edges in the Exit Actuator assembly, and check that the sensor arms are free to move. • Check for foreign objects obstructing the Exit actuator. 2. Replace the Fuser. 3. • Replace the Exit Guide. <ul style="list-style-type: none"> • Check that the Exit unit is assembled properly and full functioning and replace if necessary. 4. Replace the Exit Sensor.

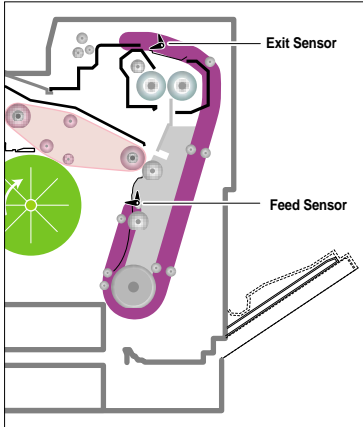
8.3.5 JAM Duplex

Symptoms "Jam in Duplex Area" indicated on the LCD panel.

Check and Cause	Solution
<ol style="list-style-type: none"> 1. Paper in the duplex path fails to operate the Feed Sensor. 2. Paper in the duplex path fails to reach the Feed Sensor. because of jamming in the Duplex Path. 	<ol style="list-style-type: none"> 1. Replace the Main PBA or SMPS. 2. Check there are no foreign objects or fragments of paper in the duplex path Replace the Duplex Unit.
